## Crushed-between Scissor Lift and Support Beam

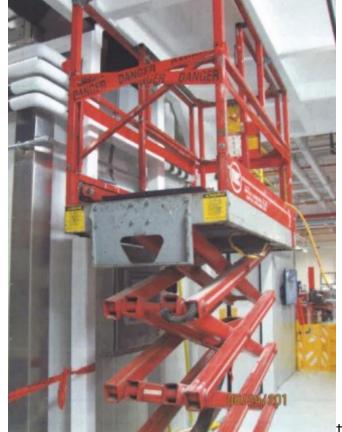
At some point while installing the insulation the victim became pinned between the

scissor lift upper guard rail and the bottom of the mezzanine outer support beam. During the investigation, it was determined that the control console on the scissor lift was missing the guard that prevents the

inadvertent activation of the lowering and rising of the work platform.

The control console was found hanging on the opposite side of the lift from the victim's work position. The most likely scenario is that the victim contacted the unguarded control console with his foot while trying to position himself leaning backwards out of the lift.

Had the guard been in place on the control panel and the victim not been working alone, it is likely this incident would have had a much different outcome. However, during the inspection it also was found the lower controls on the lift were not functioning, so it's possible that even if someone else was present they may not have been able to move the lift and free the victim in time.

This incident also highlights the importance of preventative maintenance and removing damaged or defective equipment from service until they are repaired or replaced.
