# Warehouse Supervisor Crushed by Pallet Stacking Machine

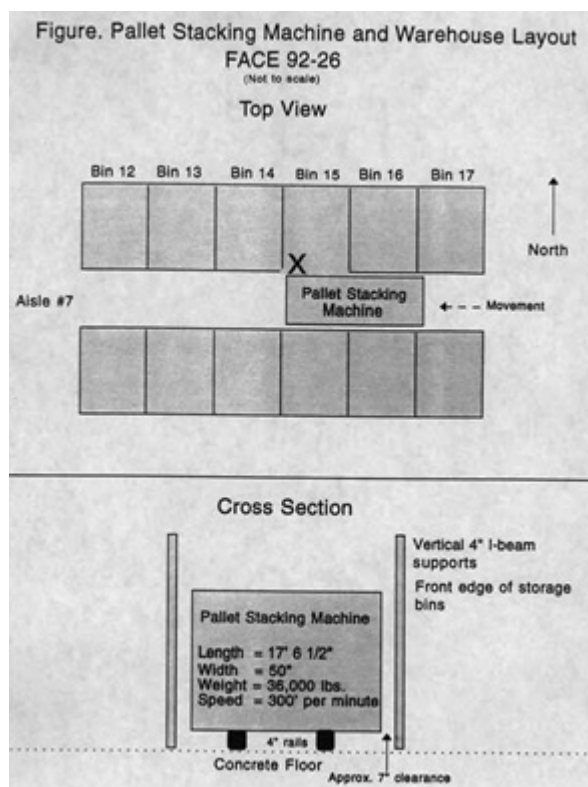
The clearance between the storage bins' vertical 4-inch I-beam supports and the stacking machine's metal frame was approximately 7 inches. The stacking machine was approximately 17-feet 6-inches long by 50-inches wide and weighed 36,000 pounds. The travel speed was about 300-feet per minute or 3½-miles per hour as it traveled in an east and west direction between the storage bins.

For unknown reasons the victim was in the aisle and had his back to the approaching stacking machine. It struck and crushed him between the stacking machine's frame and the storage rack's vertical support I-beam. His body was dragged several feet until some part of the victim's body contacted the bumper, causing the machine to stop.

The pallet stacking machine, which could be operated automatically or manually, was equipped with a switch that could have been locked out prior to entry into the aisles. Lockout was not performed in this case.

- Installation of stationary travel warning lights at conspicuous areas within the aisles.
  - Any time the machine is in operation, the stationary travel warning lights would illuminate to warn any worker in the area that the machine is in operation and to be alert to its location and movement.
- Redesigning the pressure-sensitive stop bumpers so an object located laterally, or adjacent to the machine, would contact the bumper causing it to stop.
  - The pressure-sensitive stop bumpers located on the front and rear ends of the machine, could only be activated by direct forward or rearward pressure on the bumpers.
  - An object which was positioned laterally, or adjacent to the direct line of travel (as was the case in this incident), would not engage the bumpers and stop the machine.
