# Warehouse Supervisor Crushed by Pallet Stacking Machine

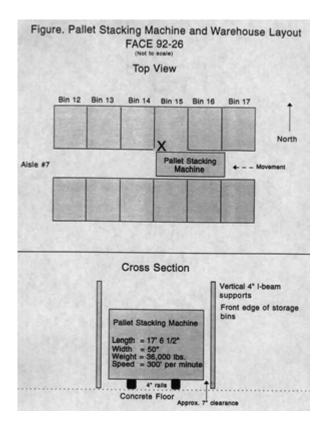
The clearance between the storage bins' vertical 4-inch I-beam supports and the stacking machine's metal frame was approximately 7 inches. The stacking machine was approximately 17-feet 6-inches long by 50-inches wide and weighed 36,000 pounds. The travel speed was about 300-feet per minute or  $3\frac{1}{2}$ -miles per hour as it traveled in an east and west direction between the storage bins.

For unknown reasons the victim was in the aisle and had his back to the approaching stacking machine. It struck and crushed him between the stacking machine's frame and the storage rack's vertical support I-beam. His body was dragged several feet until some part of the victim's body contacted the bumper, causing the machine to stop.

- Creation of specific procedures to follow prior to any work being performed in the aisles. Including:
  - Locking and tagging the machine in the off position when personnel are in the aisles.
  - Retaining the key until all work is completed and the aisles are clear of personnel.
- Consider using two workers to perform any work in the aisles. One worker would be responsible for monitoring the movement of the machine while the other worker performs the task.
  - If the victim hadn't been working alone it is possible the second employee

- Installation of stationary travel warning lights at conspicuous areas within the aisles.
  - Any time the machine is in operation, the stationary travel warning lights would illuminate to warn any worker in the area that the machine is in operation and to be alert to its location and movement.
- Redesigning the pressure-sensitive stop bumpers so an object located laterally, or adjacent to the machine, would contact the bumper causing it to stop.
  - The pressure-sensitive stop bumpers located on the front and rear ends of the machine, could only be activated by direct forward or rearward pressure on the bumpers.
  - $\circ$  An object which was positioned laterally, or adjacent to the direct line of travel (as was the case in this incident), would not engage the bumpers and stop the machine.
