Is This a Safe Way to Guard a Floor Opening?

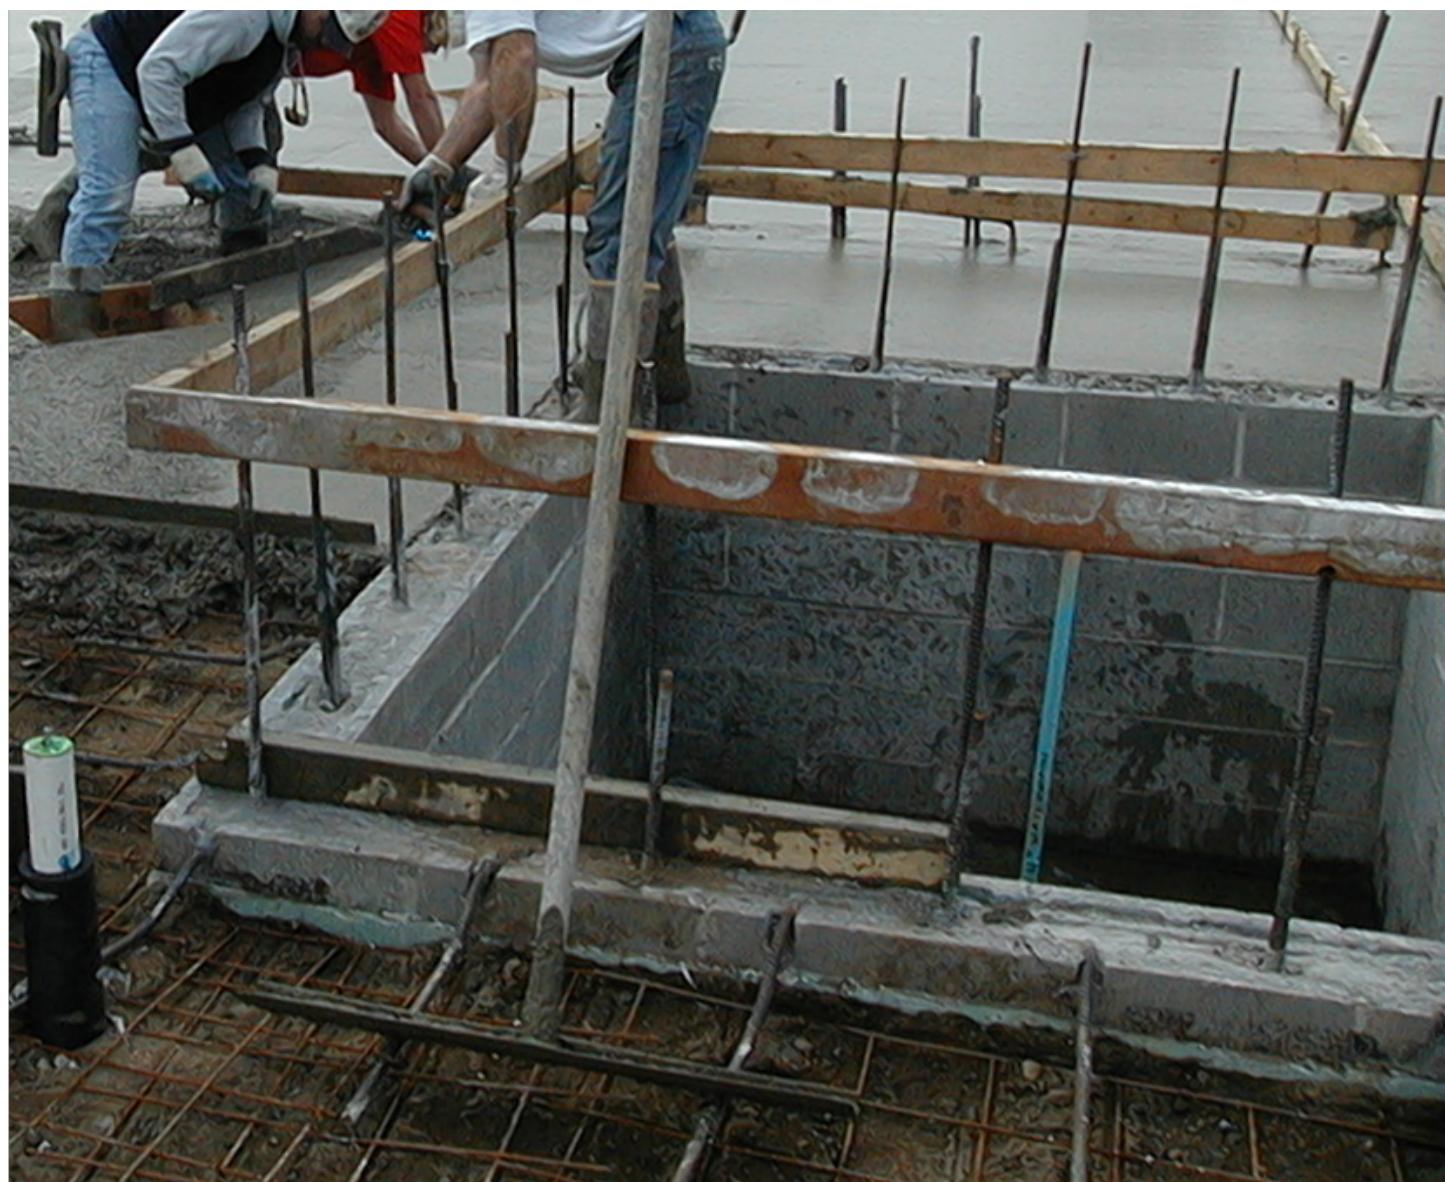
What is wrong with this picture?

The railing arrangement in this photo is in some ways more dangerous than the floor hole it's guarding:

- There's no intermediate railing; and

- The post ends jutting out from over the top railing are uncapped and could cause serious damage if workers stumble into them.

The railing in this photo is clearly not up to “standard.”

Moral: Make sure your floor hole guarding arrangements meet OSHA standards and don't expose workers to additional hazards.

OSHA (Sec. 1910.23(a)(8)) says that floor openings must be guarded by **EITHER:**

2. **A Standard Railing and Toeboard** on all exposed sides.

1. A top rail that’s smooth-surfaced throughout the length of the railing;
2. An intermediate rail that’s located about halfway between the top rail and floor/platform/runway/ramp;
3. Posts;
4. At least 42 inches in height measured from the upper surface of the top rail to the floor/platform/runway/ramp;
5. Ends of rails that don’t overhang the terminal posts (unless the overhang doesn’t constitute a projection hazard).

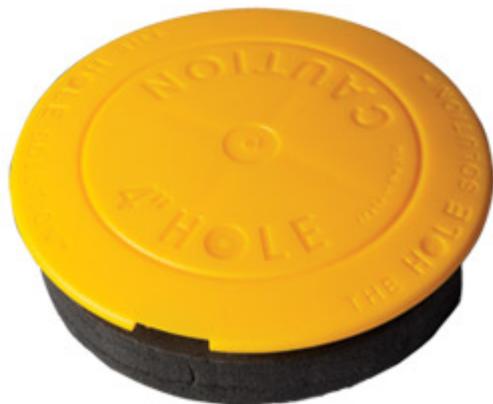
1. **A Floor Hole Cover** of standard strength and construction;
