# Steel Panel Crushes Bank Vault Installer

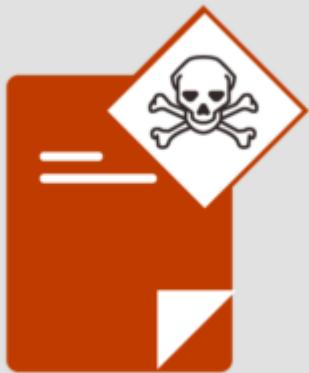
A bank vault installer was crushed to death between a forklift and a steel panel.

Ordinarily the panels are moved by a lifting device which is part of the vault panel. However, on this vault panel the device was damaged and defective. Instead, chains had been used to hold the panel in place on the forks. The panel could not be moved into the correct position because of the chains, so the victim reached up to make an adjustment to the chains.

The panel started to fall, pulling the forklift over with it. The victim was pinned between the forklift roll bar and the vault panel. He was trapped for 36 minutes before he could be extricated by the fire department's jaws of life. He died of crushing injuries.

*Don't use makeshift lifting or slinging systems. In this case, the makeshift lifting arrangement, of chains instead of an eyebolt, did not work. When using lifting and pulling equipment, observe load limits and established safe work procedures.*
