# Upper Boom Failure on Aerial Lift

## Incident Summary

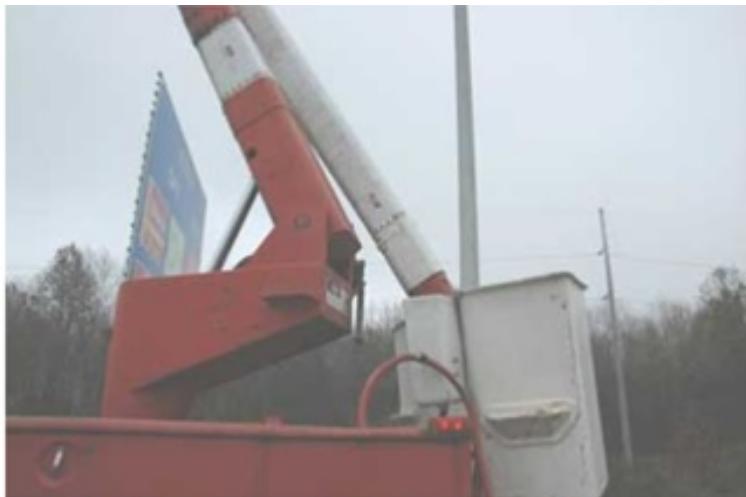
A 45-year-old owner of an electrical contracting company died after falling 9 feet to the road when the articulating boom of the aerial lift truck he was working from collapsed (photo 1).

**Photo 1: Aerial lift boom after incident. Note that the lower boom section remains elevated while the bucket-end of upper section is in a lowered position (photo courtesy of OSHA).**

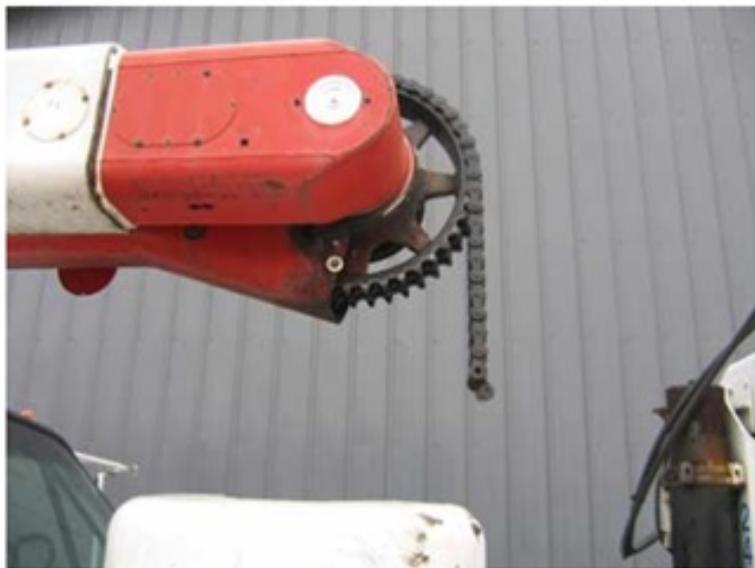
Post incident inspection of the articulating boom revealed the boom actuating chain had separated resulting in the catastrophic collapse of the upper boom (photo 2).

Photo 2: Broken boom actuating chain (photo courtesy of OSHA).

It appears lack of proper lubrication of the chain is likely what caused the chain to break. This incident highlights the significance of:

1. Reading and adhering to the manufacturers' recommended maintenance schedule. The operation and maintenance manual detailed maintenance recommendations, procedures and warnings.

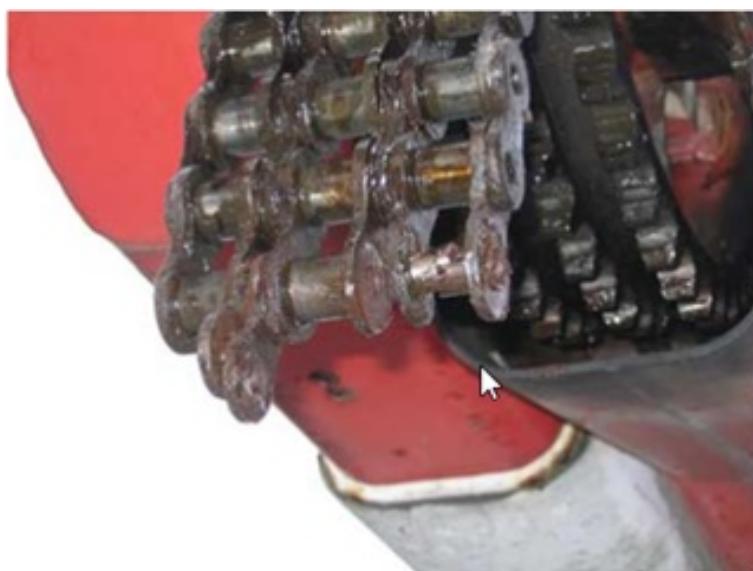
- In particular, the manufacturer recommended the roller chains, including the upper boom actuating chain, be lubricated every 30 days.
- A warning in the manual stated a lack of lubrication can cause galling and corrosion of the chain pins; breakage of the pins; and result in free fall of the upper boom (photo 4).

Photo 4: Broken section of boom actuating chain  
(photo courtesy of OSHA).

2. Pre-use inspection and removing suspect equipment from service until has been made safe to use.
3. Regular maintenance and inspection by a qualified person.

- The operation and maintenance manual recommended regular maintenance and inspections to include – the upper boom actuating chain for lack of lubrication, broken rollers and pins.
- It also stated lack of lubrication is indicated by squeaking or groaning noises when the booms are moved.
- The recommended inspection/maintenance frequency for pulleys, sprockets, pins and chains is monthly. A major overhaul of the unit was recommended, according to average use, after 3 years or 6,000 hours of use, whichever came first
  - The aerial lift involved in this incident was 18 years old.
  - There was no record of maintenance and inspection having been performed on the boom structure or other assemblies of the aerial lift.
