Fall Through Temporary Roof Opening

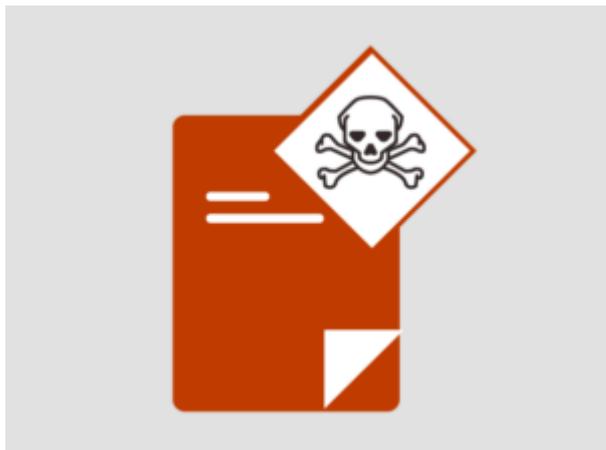
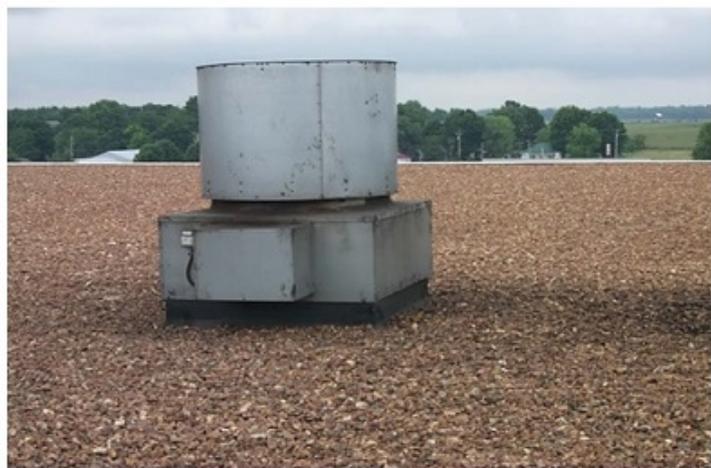
Exhaust fan had been removed for cleaning, creating a temporary opening where cleaner fell approximately 35 feet/10 meters onto a piece of machinery in the factory.

1. Openings in roofs, floors, and walls must be barricaded, protected with a guardrail system, or covered with marked covers to prevent someone from unintentionally falling through them.

b. After this incident occurred, the company constructed covers of 2 x 4s and plywood nailed together to be placed over the temporary holes in the roof while the fans were removed.

c. Additionally, a moveable four-wall, five-foot-high barricade could have been constructed for the roof openings. This would have allowed the factory air to exhaust through the roof openings while the fans were being cleaned.

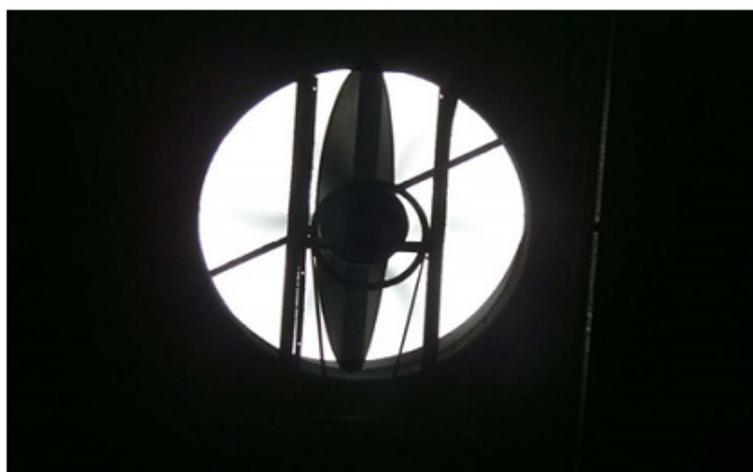
Exhaust fan above machinery on factory floor.

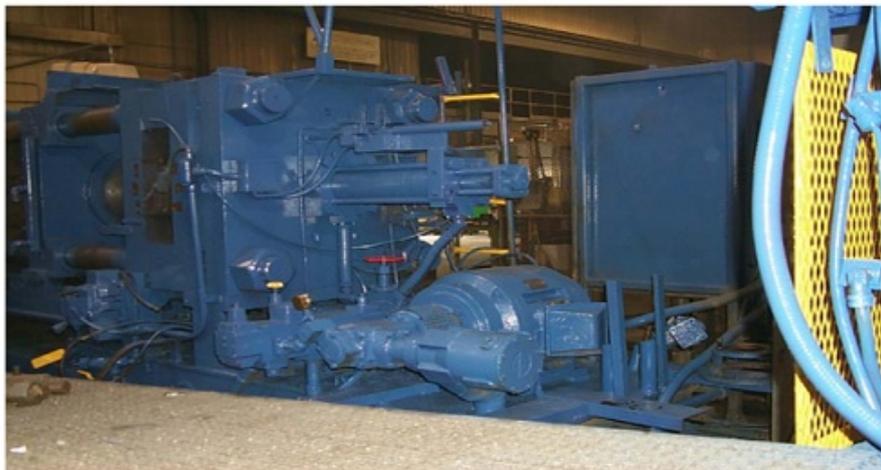
He fell onto a 1200-ton die-casting machine on the factory floor. Onsite personnel working nearby heard the cleaner fall onto the machine. They summoned help and factory-employed emergency response personnel responded to the scene, assessed the

Machinery victim fell on.
