Chemical & Process Safety: Lessons from Past Explosions Picture This

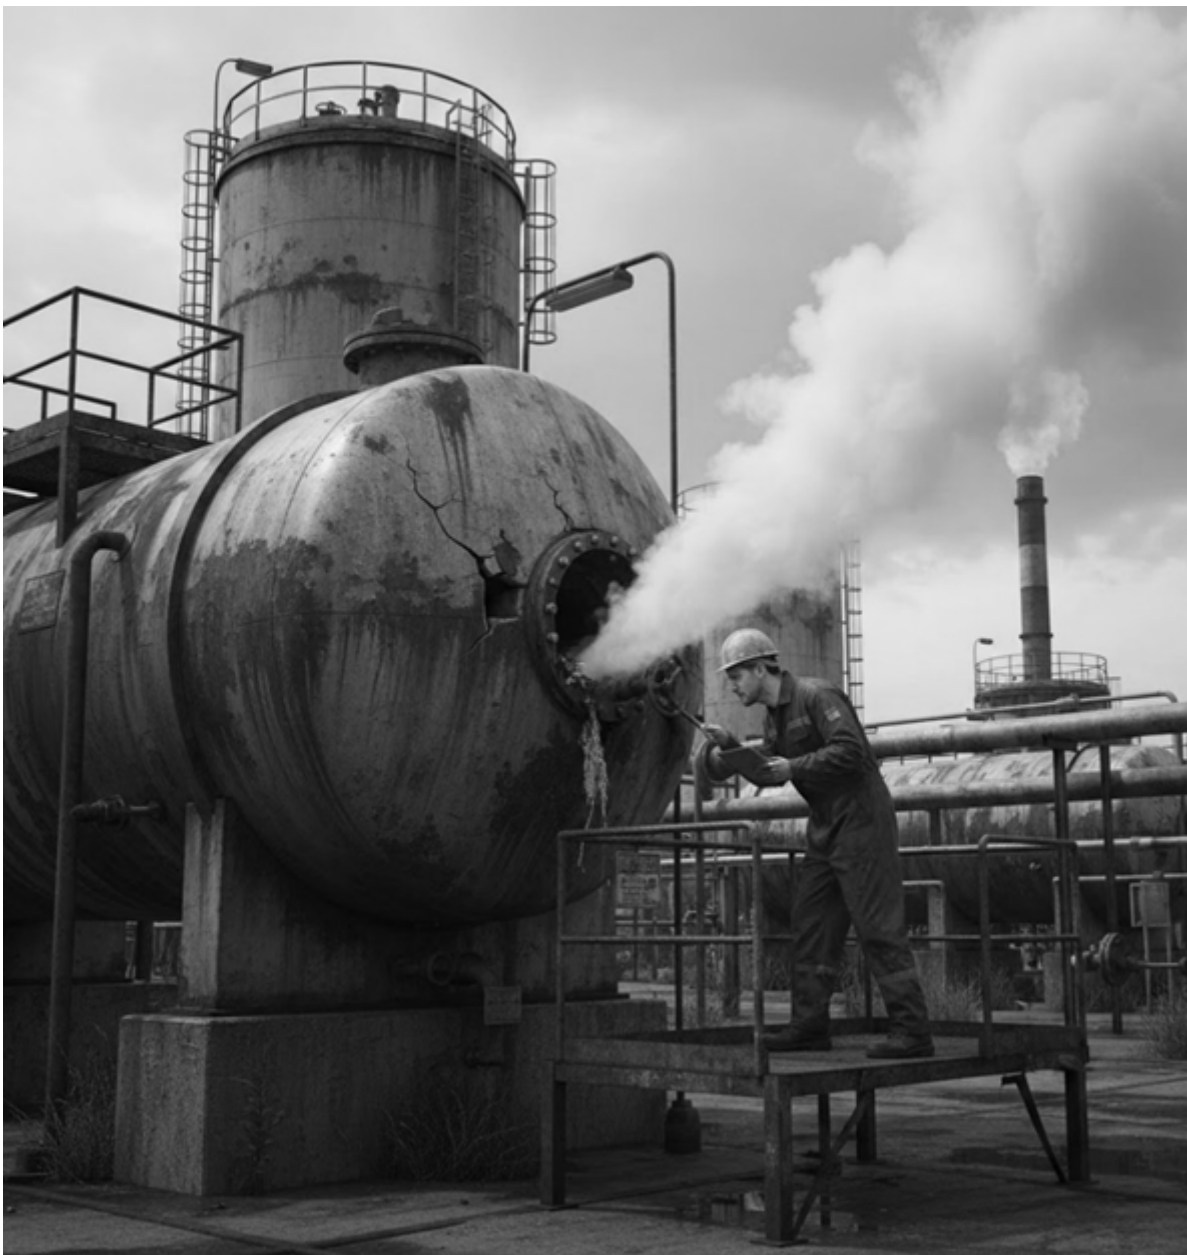
In the image, the worker is standing directly in front of a severely damaged pressure vessel that is forcefully venting steam through a cracked opening. Instead of evacuating, he is leaning in to inspect the leak with no protective equipment and no

barriers in place. The tank's corroded surface and visible structural cracks indicate long-term neglect and a high likelihood of rupture. This is precisely the type of unsafe behavior that has led to catastrophic industrial explosions in past incidents.

Workers must immediately evacuate and isolate the area when a pressure vessel shows signs of over-pressurization, leakage, or structural failure. Emergency shutdown procedures, remote pressure monitoring, and blast-radius controls should be activated while trained personnel respond from a safe distance. Regular inspections, corrosion control, and adherence to mechanical-integrity standards prevent such failures from developing. Applying lessons from past explosions ensures facilities operate safely and avoid repeating deadly process-safety mistakes.
