# Gas Blows Up Inside Steel Ladle

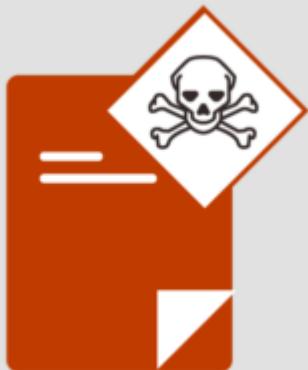
A worker in a steel mill was removing steel slag from the bottom of a ladle, about 14 by 10 by 8 feet in size. He was using a jackhammer, a pry bar and an oxyacetylene cutting torch.

On the day of this incident, several things were out of the ordinary. The worker had dismissed the assistant who usually provided safety watch while he worked in the bottom of the ladle. The ladle was in an upright position instead of on its usual side, and the plug at the bottom of the ladle had not been removed as usual to allow ventilation.

The worker routinely removed the cutting torch when not in use, but on this occasion he left it in the bottom of the ladle when he went for a coffee break. When he returned, he lit the cutting torch to start work, an explosion occurred and he was engulfed in flames. Investigation later showed the torch had been leaking gas into the ladle. The accumulated gas exploded when ignited.

*A confined space, fuel and a source of ignition add up to an explosive combination. Follow all safety procedures every time, even for a quick task, or a job you have regularly performed many times.*
