Picture This: Missing Guard Turns Deadly

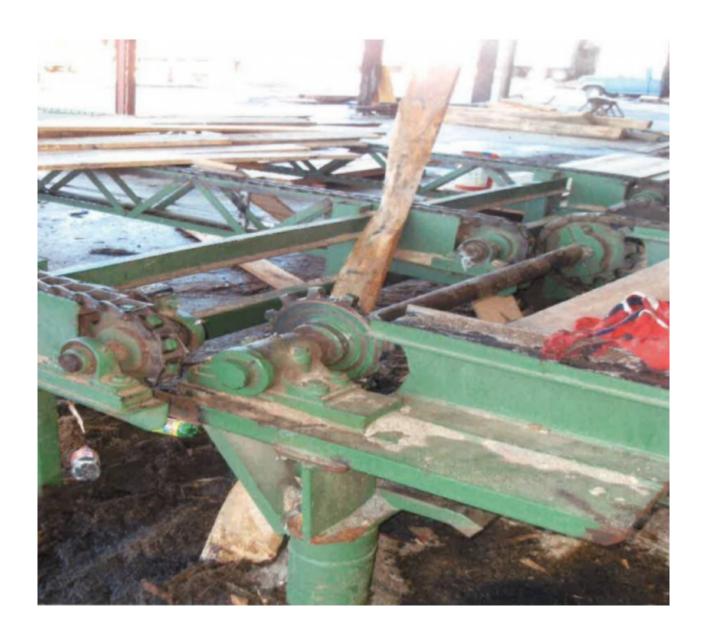
This image shows a lumber sorting conveyor with no guards in place to protect workers from the moving chains

and gears or rotating shafts of the conveyor system. As a result, a worker lost his life when he reached between

the two moving chains to clear out a piece of lumber that had fallen - also seen in this image. His coat caught

between the chain and the gear and he was pulled into the conveyor and his body was wedged between the drive

system and the framework of the conveyor.

Rotating parts, moving belts, points of operation, and other similar machine hazards must be guarded to protect

workers from injury, amputation, and death. In addition, lockout/tagout procedures must be in place and enforced

during times of repair, maintenance, and removal of materials. Finally, jam-clearing tools and procedures must also

be used and followed so workers aren't reaching into a machine, its point of operation, or over any rotating, spinning, or moving parts.
