# Tank And Crane Topple To Ground

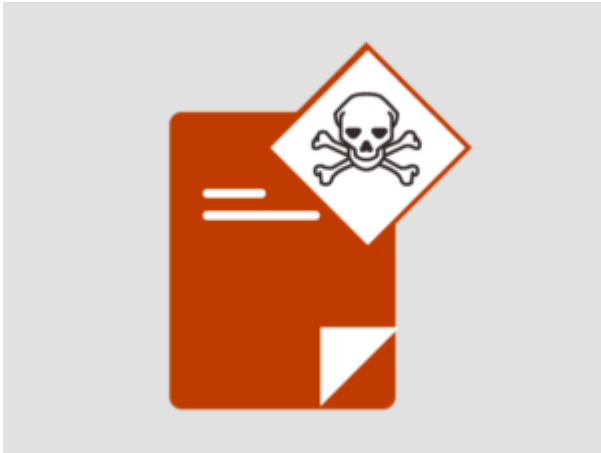
An empty water tank weighing 14 tons (12.7 metric tons) was being lifted by a crane onto a water tower frame. The land around the new community water tower had been excavated the previous month and refilled. Instability in the ground caused the crane to begin toppling toward the water tower. The crane and tower both fell, knocking down nearby power lines. The crane operator was injured. A worker in a ladder cage on the tower was also hurt. Another worker, waiting on the tower for the water tank to be placed, died of massive injuries to the head, chest and abdomen. Investigators made recommendations to prevent a similar tragedy. They said cranes must be set up properly, with outrigger pads on stable footing.

*The lifting operation should be monitored closely for signs of instability from the ground or the load. Pre-lift engineering of ground stability would also have been in order.*
