Verifying Safeguards Picture This

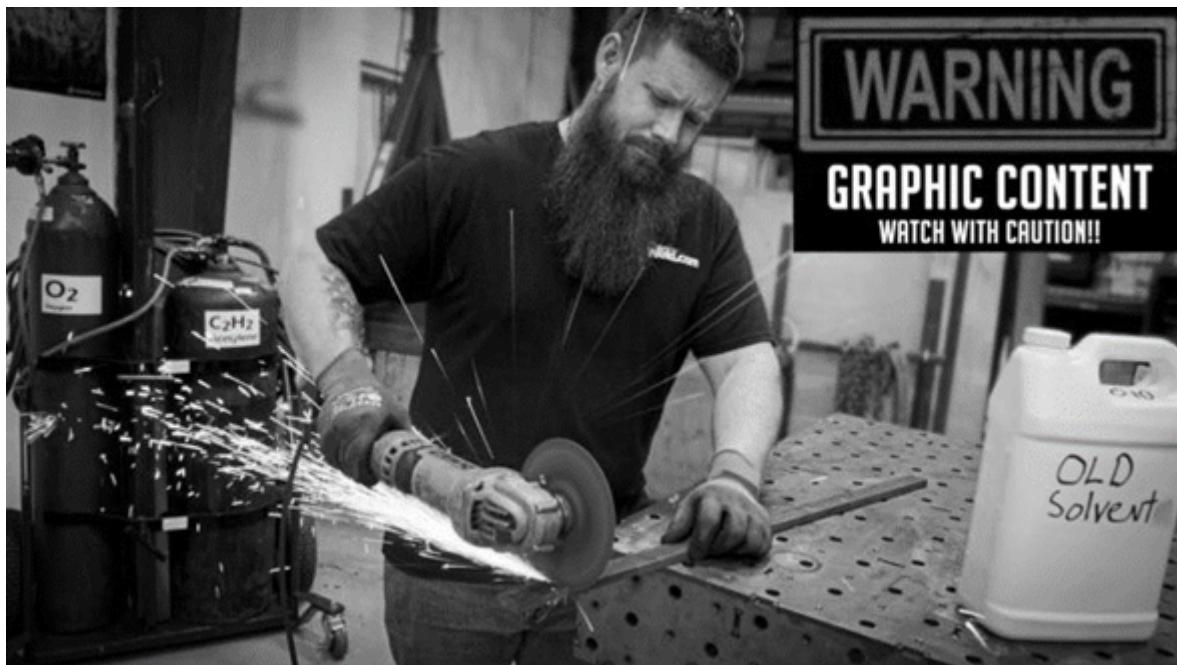
What is wrong in this picture? There is a man doing multiple unsafe procedures in this picture, first he is using a grinding wheel without any guard, second all the sparks coming out of the machine are falling into two oxygen cylinders which makes it too dangerous, third he is not wearing any facial mask or glasses to protect his eyes from those sparks and finally there is a solvent knob close to his work area. All of those unsafe procedures are strongly dangerous that can result in a horrible disaster with many injuries, burns and even death.

Never use a machine without the guard which is provided for protection. Check the machine for any kind of crack or damage before using the grinder.

Never use a machine without wearing all the personal protective equipment and clothing such as goggles, helmets, masks, ear protection, gloves, leather aprons etc. Also ensure that the personal protective equipment and tools are in proper condition before using them.

Finally, make sure all safeguards are in place to avoid a catastrophe, check your work area before start working, follow all safety work practices and ensure your personal safety.
